**EMERGENCY STRUCTURAL ASSESSMENT
OF
EARTHQUAKE DAMAGE TO
NORTH KAWAIHAE SMALL BOAT HARBOR
LOCATED AT
KAWAIHAE, HAWAII**

**PREPARED FOR
THE STATE OF HAWAII
DEPARTMENT OF LAND AND NATURAL RESOURCES
DIVISION OF BOATING AND OCEAN RECREATION**

**PREPARED BY
ARNOLD T. OKUBO & ASSOCIATES, INC.
94-529 UKEE STREET, SUITE 107
WAIPAHU, HAWAII 96797**

NOVEMBER 2006

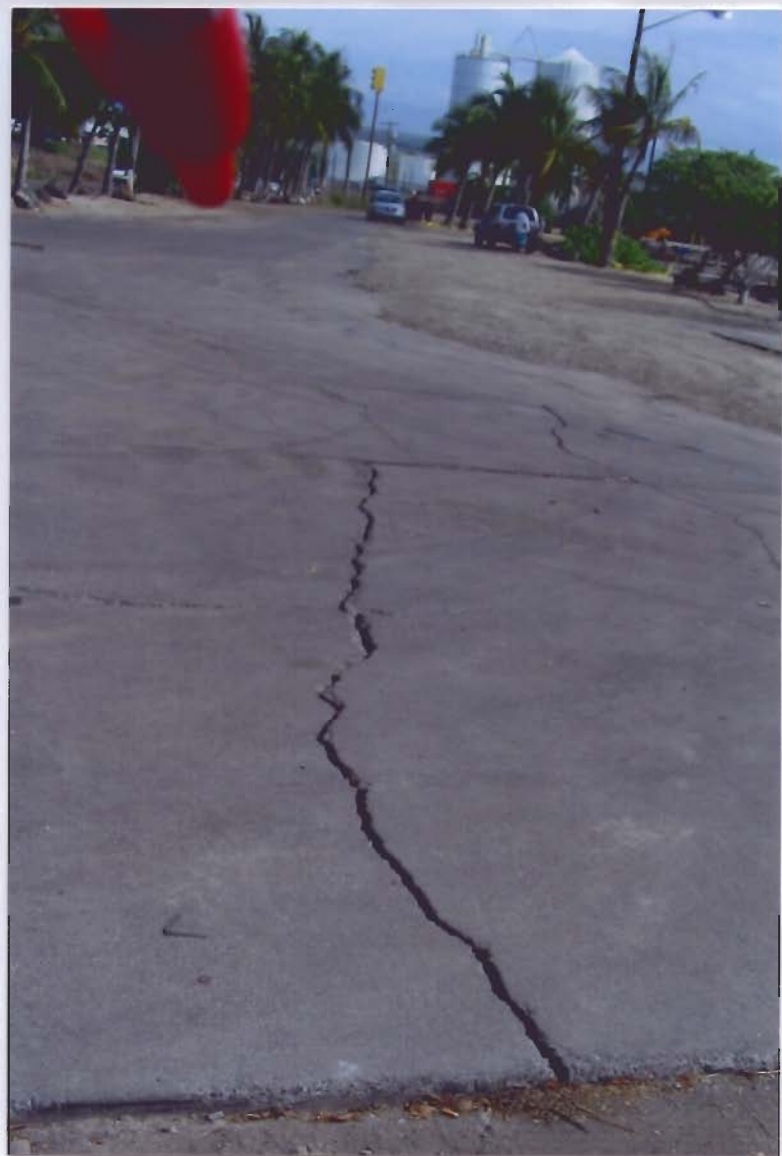
37

Cracks at Boat
Ramp Concrete
Pavement Slab

The boat launching ramp has significant cracks and should be reconstructed. The approach slab and pavement also has large cracks throughout and should be reconstructed.

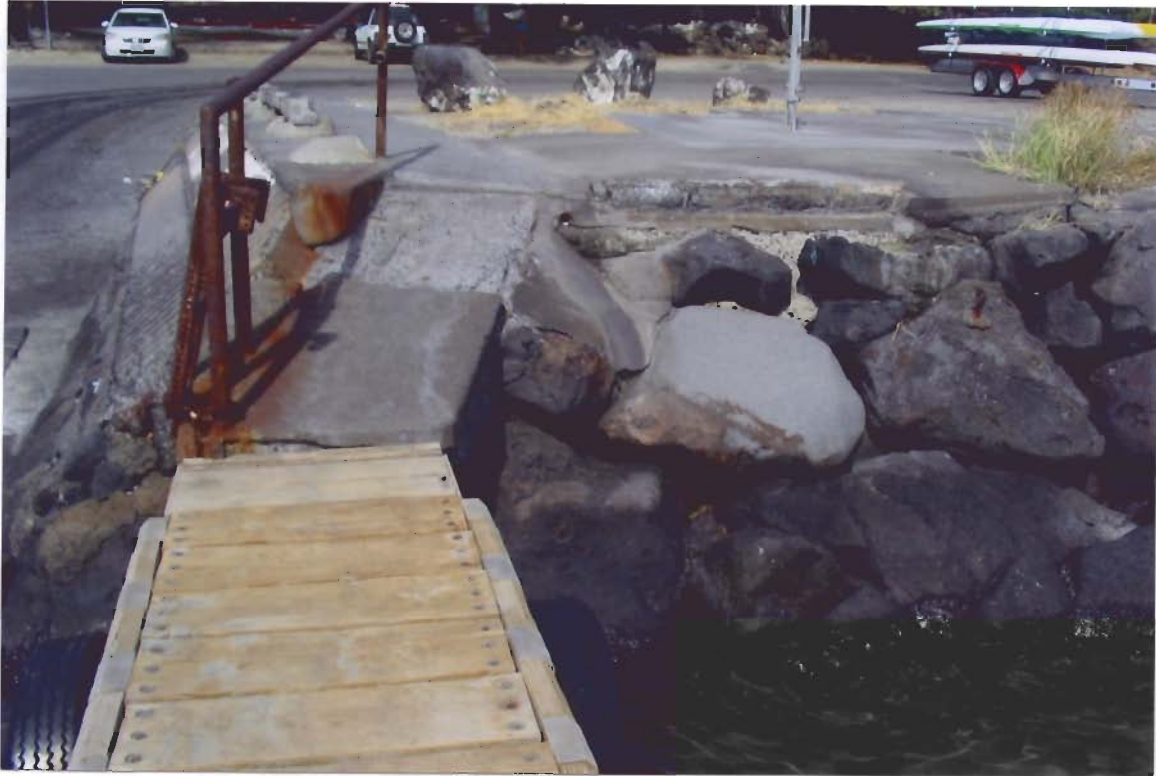
Concrete slab walkway and wall have significant cracks.

38 Loading Dock No. 1 - Cracks at Concrete Approach Walkway Slab

The loading dock No. 1 walkway slab and wall are cracked and should be reconstructed.

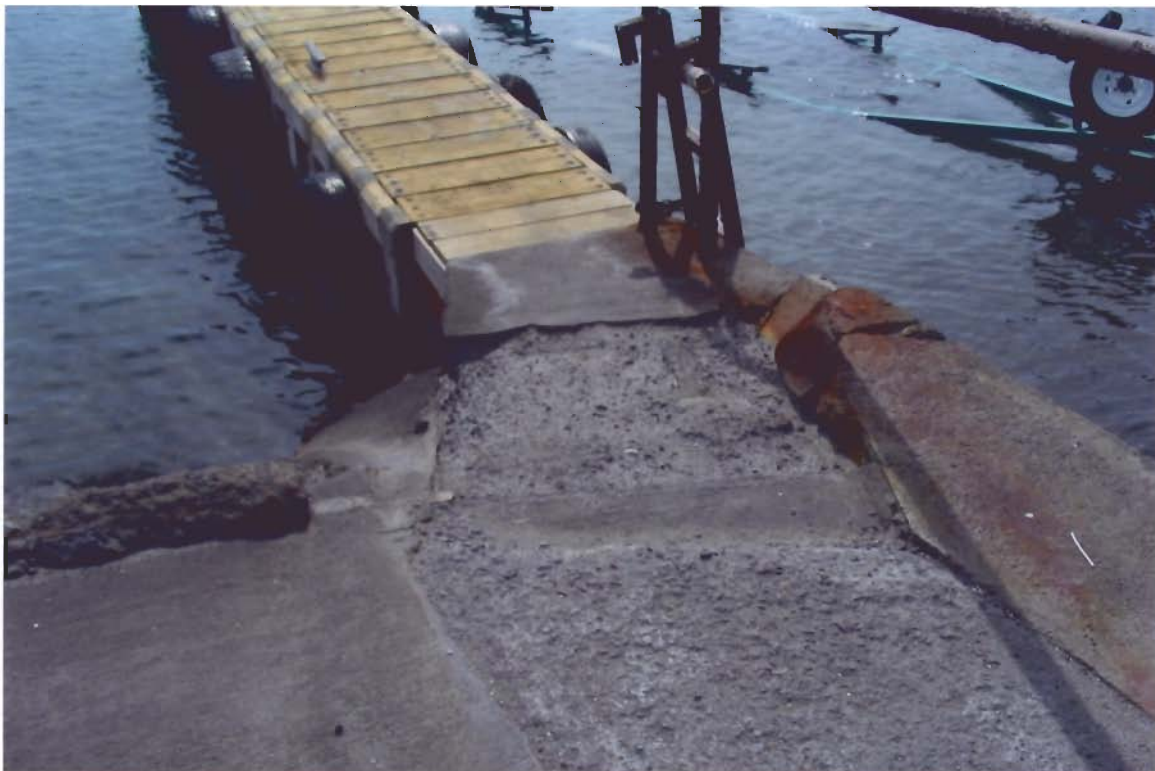
39 Loading Dock No. 1 - Cracks at Concrete Approach Walkway Slab

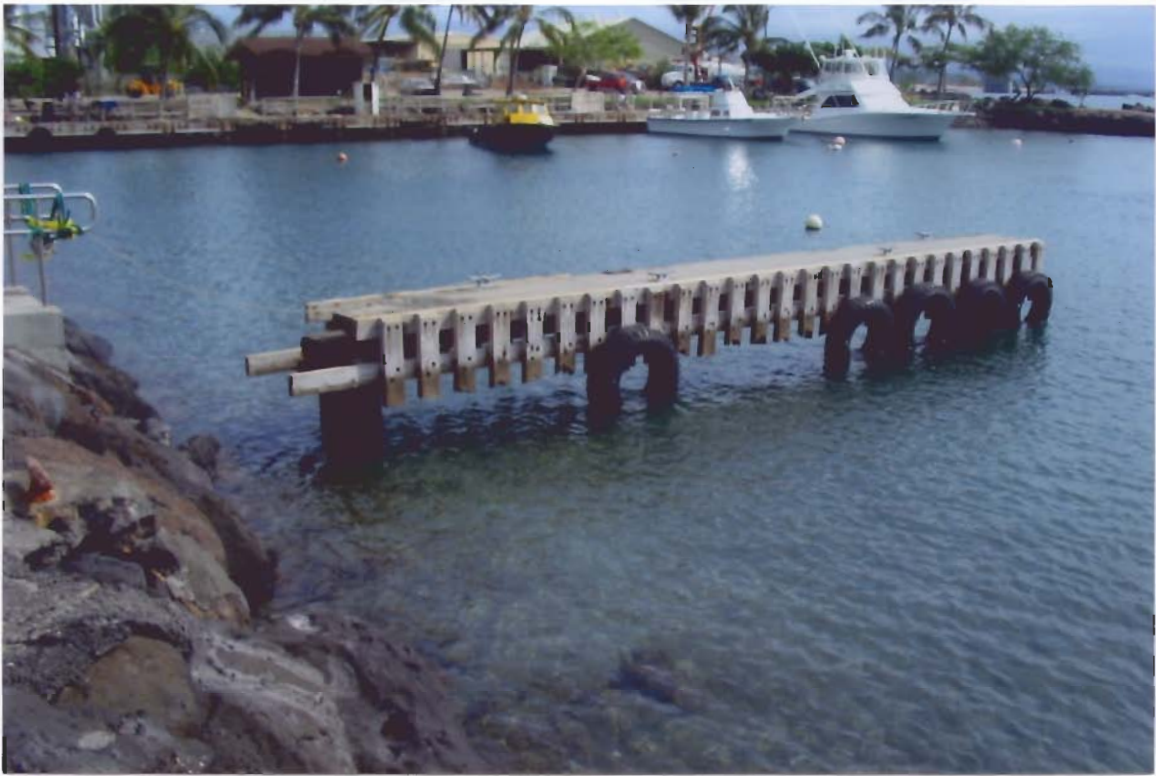
42

Loading Dock No. 2 was previously damaged before the earthquake. There is no approach ramp to the dock and the dock is not being used.

Loading Dock No. 2 -
No approach walkway to dock
